**TSI 04/2011**

New seal for the camshaft sprocket cover  
Mercedes-Benz OM 457 LA | HLA

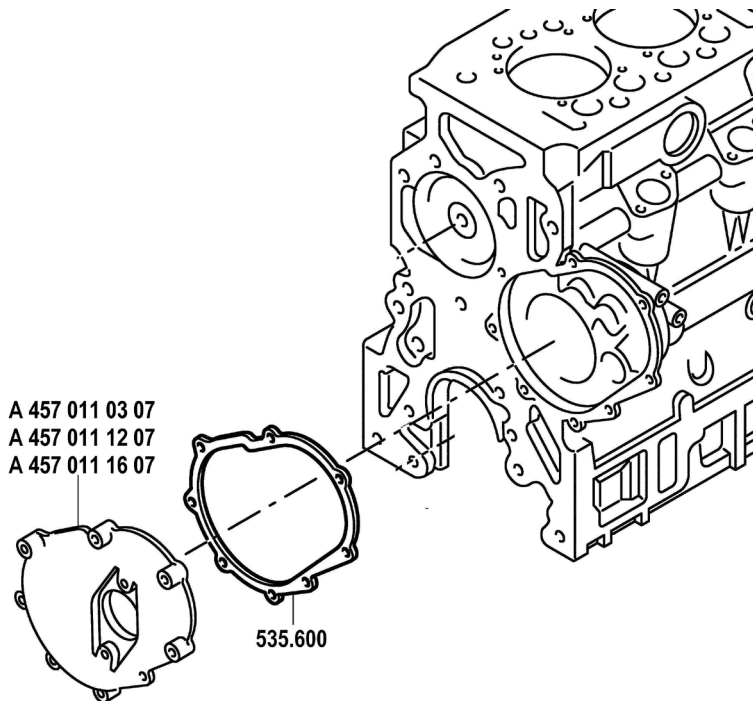
In order to improve seal performance between the camshaft sprocket cover and the engine block, a new Metaloseal<sup>®</sup> has been developed. It replaces the sealing compound that was previously used for this joint.

In order to prevent damage to the belt drive, the camshaft sprocket cover must be replaced!
