## Repair solution for the water pump gasket

**B07.530 | BMW**

SI 02/2024

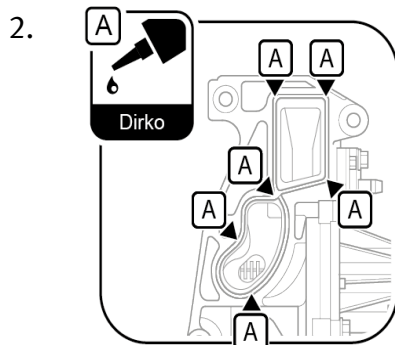
The old gasket is first removed using a suitable tool. Before installation, make sure that the surface is clean and free from residue. Sealing compound points (see Figure no. 2) must be applied to ensure that the gasket remains in the correct place during installation. To ensure that the EPDM gasket functions perfectly, you should wait 30 minutes after installation.
